ELA AVIACIÓN, S.L.
SERVICE BULLETIN Nº 17.

Inspection/action required in new type of rotor hub (P/N: 07-143)

Date of issue: 5th September 2013.

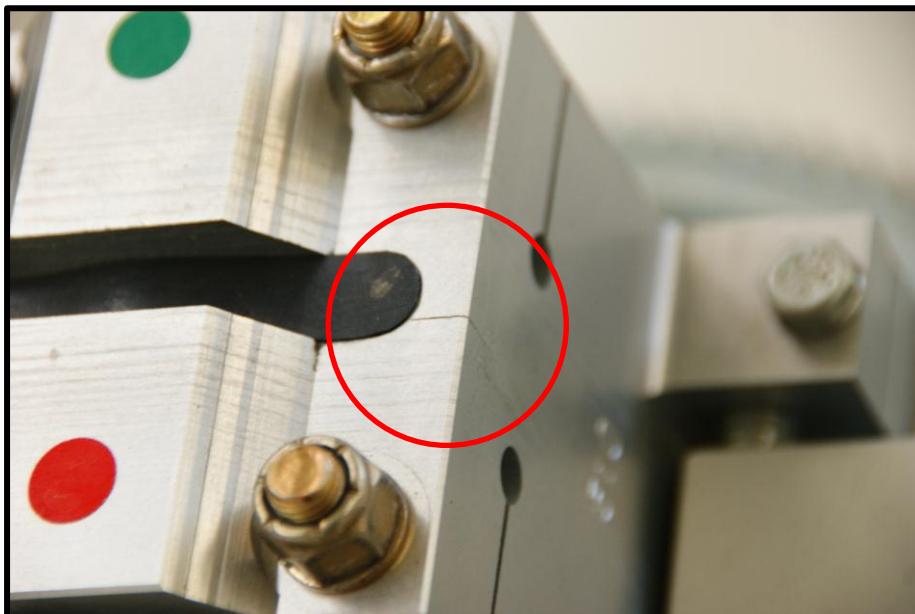
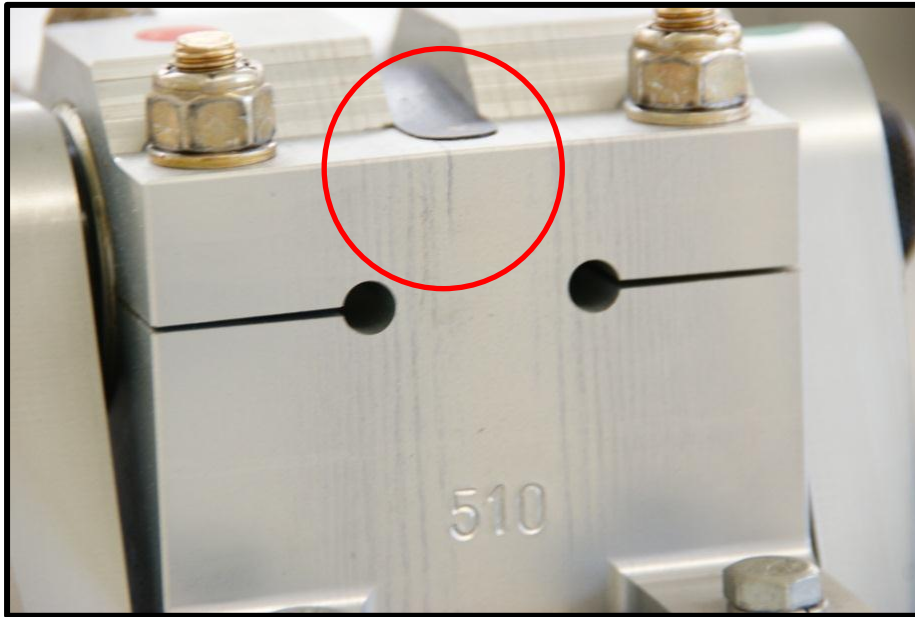
A few customers have reported small cracks in this part. See pictures.

After investigation of those cracks we have determined that the tightening of the four bolts that hold the hub bar to the block (rotor hub) can cause the appearance of those cracks.

Rotor hubs with apparition of cracks are not airworthy and should be replaced.

1) A visual inspection is required before the next flight to confirm the absence of cracks.
In case of cracks contact the factory for replacing the rotor hub.

2) Installation of the new sheets to avoid the stress in the affected area.
