ELA AVIACIÓN, S.L.
SERVICE BULLETIN Nº 17.

Inspection/action required in new type of rotor hub (P/N: 07-143)

Date of issue: 5th September 2013.

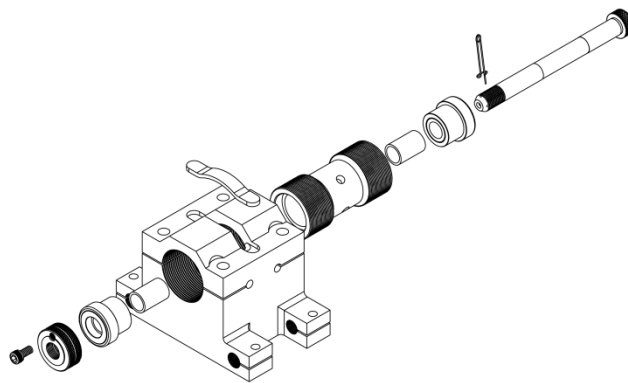
A few customers have reported small cracks in this part. See pictures.

After investigation of those cracks we have determined that the tightening of the four bolts that hold the hub bar to the block (rotor hub) can cause the appearance of those cracks.

Rotor hubs with apparition of cracks are not airworthy and should be replaced.

1) A visual inspection is required before the next flight to confirm the absence of cracks.
In case of cracks contact the factory for replacing the rotor hub.

2) Installation of the new sheets to avoid the stress in the affected area.
